**2008 Operations, Maintenance,  
and Monitoring Report**

**PERRY RIDGE SHORE  
PROTECTION**

State Project Number CS-24  
Priority Project List 4

June 2009  
Calcasieu Parish

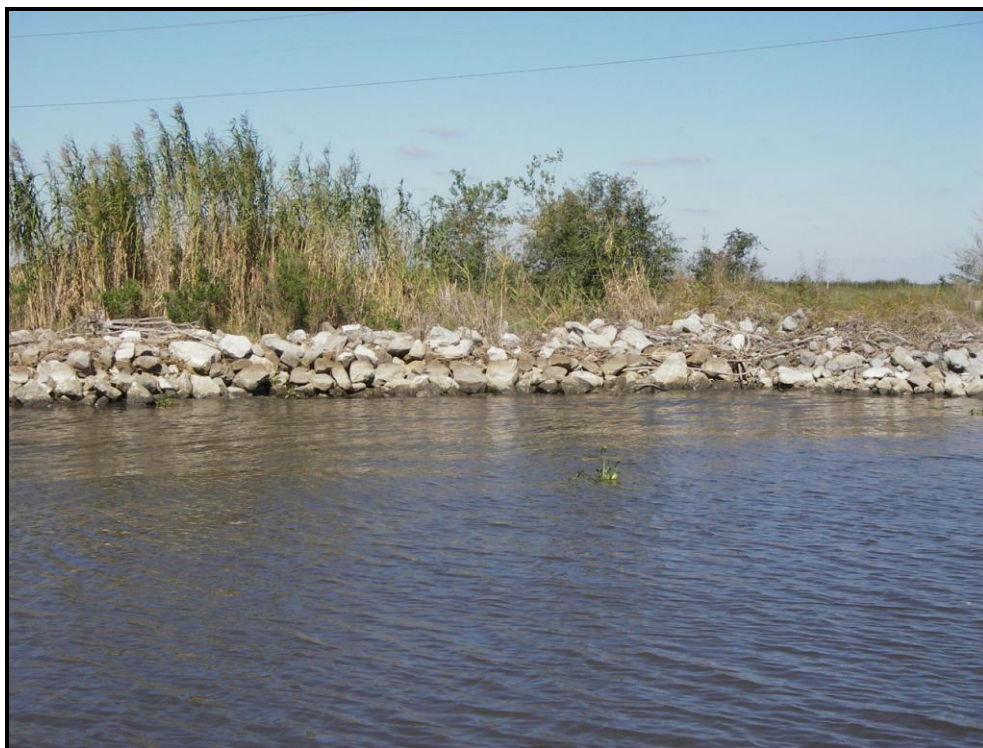
The dike is in excellent condition with some very small areas being below constructed elevation. Visible signs of accretion are occurring behind the rock dike in some areas. No maintenance is recommended at this time. (Photos: Appendix A, Photos 1, 2 & 3)

**Photo 1,** Typical rock dike.

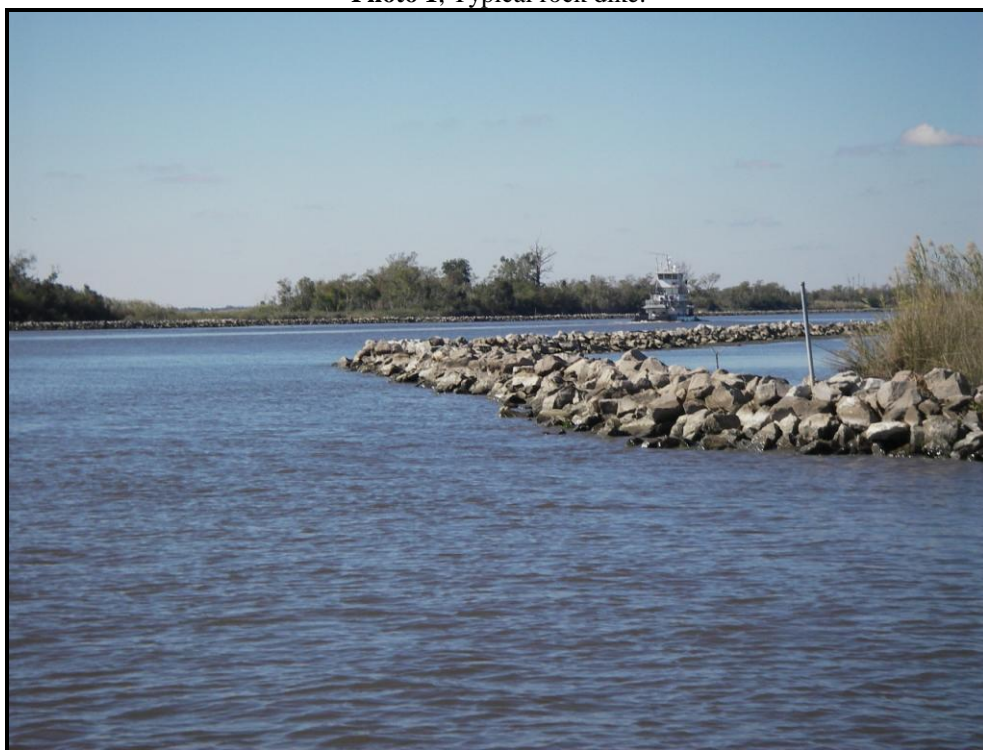
**Photo 2,** Rock dike tie-in on eastern end.
